**AGENDA**  
**GIG HARBOR PARKS COMMISSION MEETING**  
**Wednesday, October 4, 2023 – 5:30 p.m.**  
**Community Rooms**

# Arborist Report

## Tree Risk Assessment Report

### Skansie Park Apple Tree

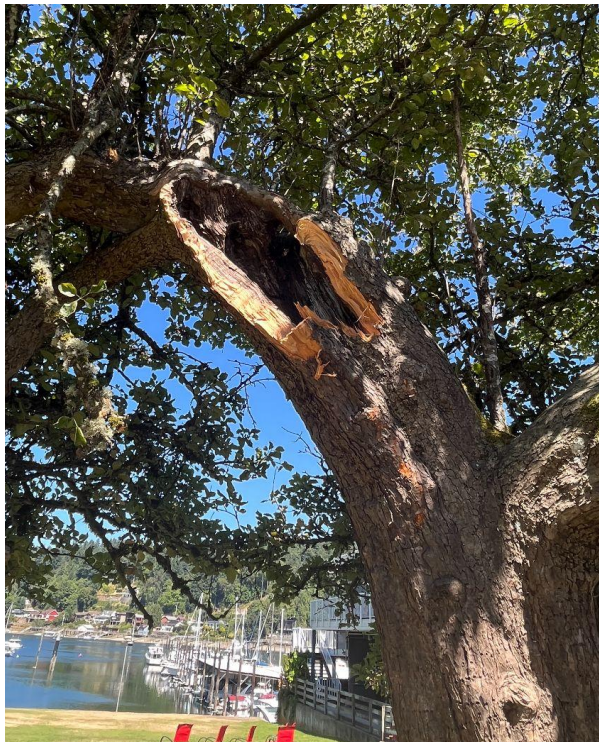
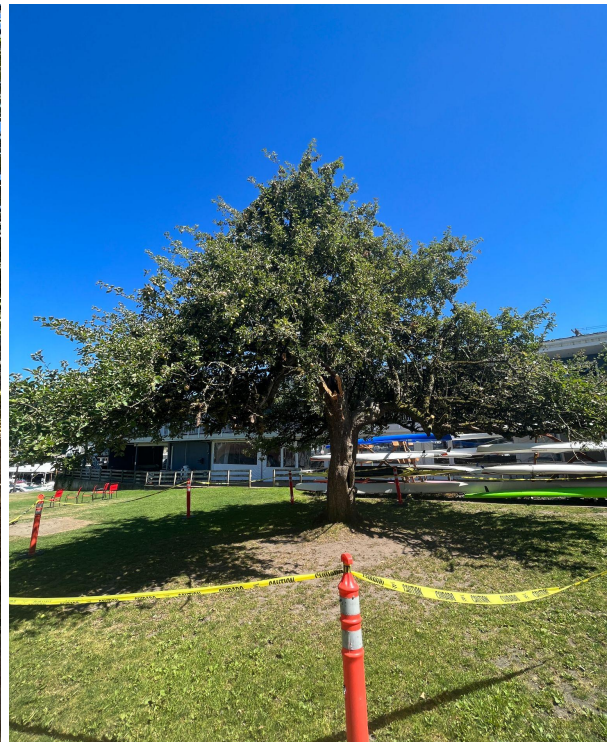
## Tree # 657 - Apple Tree (*Malus spp.*)

**Crown and Branches** - There was a recent large branch failure approximately ~10 feet up from the base. There are similar branches present to the one that failed. The canopy was very large and the foliage was prolific and healthy. Fruit production was significant, adding considerable gravitational force to the limbs. Many of the branches were poorly formed (watersprouts, crossing rubbing branches, & weak attachments). The remaining large scaffold branches were growing laterally. The failed branch revealed a hollow trunk that extended down to the ground.

**Trunk** - The trunk of the tree was completely hollow with only 2-3 inches of holding wood the trunk was ~8 feet tall.

**Roots and Root Collar** - The tree was growing in a heavily trafficked lawn area. Grass was growing up to the trunk. The soil was compacted in the root zone of the tree.

The likelihood of branch failure is **PROBABLE** with a **HIGH** risk of impacting people within the dripline. This event is **LIKELY** and the consequences of impact are **SIGNIFICANT**.

**HIGH**

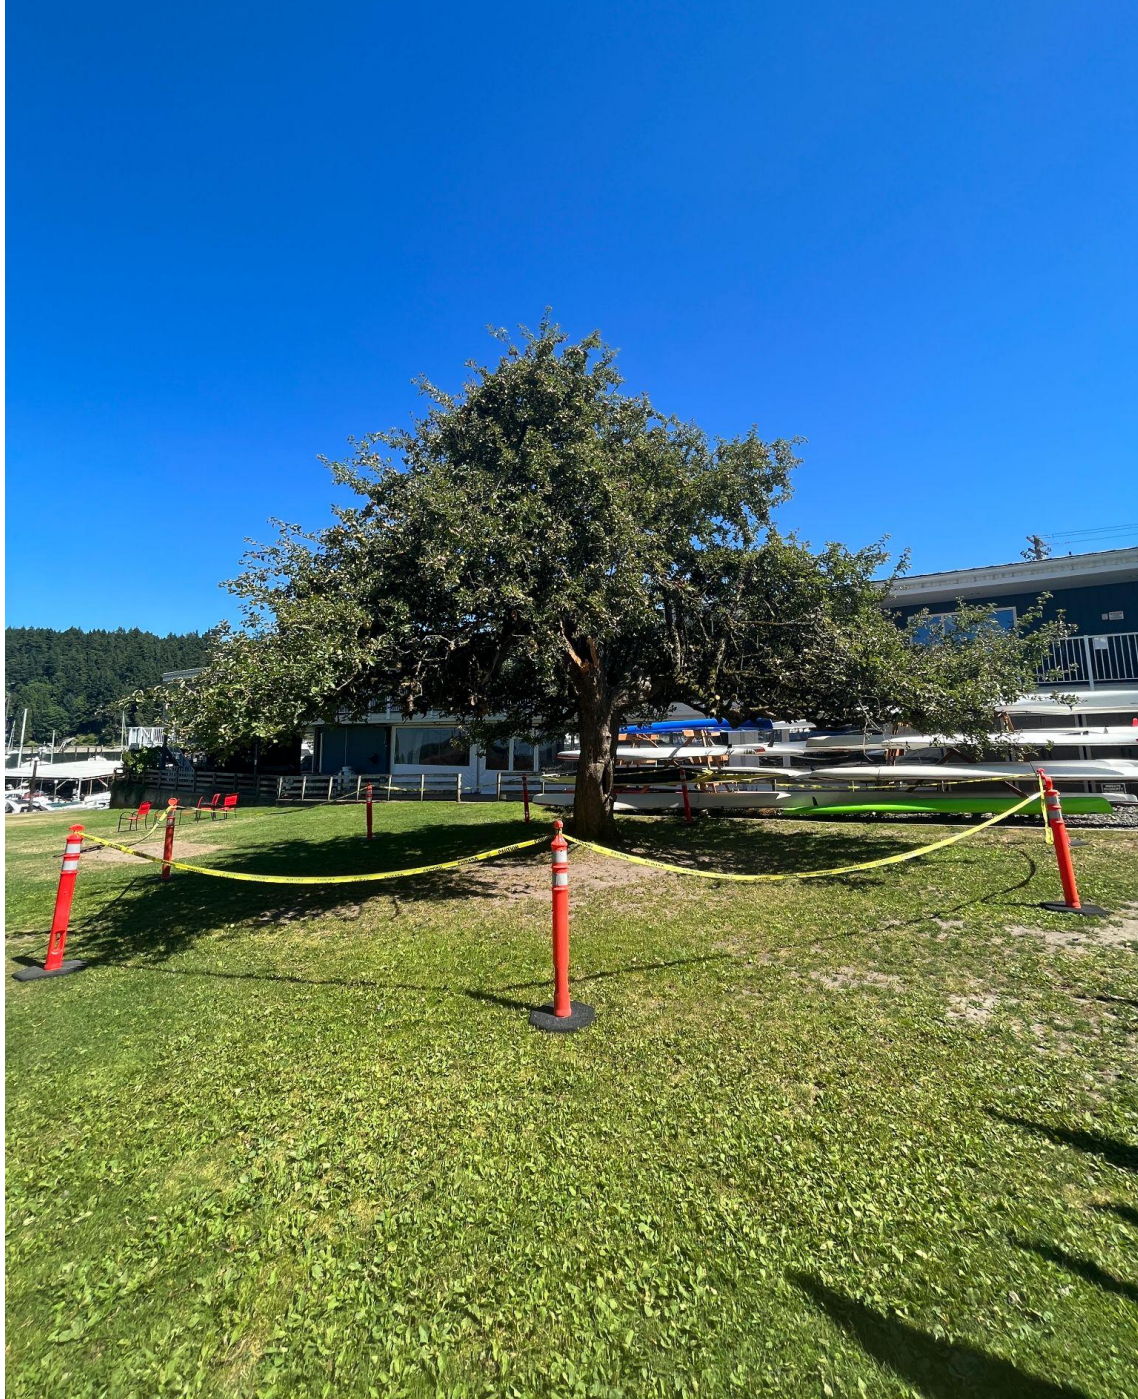
***Image B1. The apple tree is one of two trees in the park, both of which have suffered recent large limb failures. Regular annual pruning helps to improve tree structure and reduce end weight on weak branch unions.***

If the tree is to be retained, it is recommended that the grass be removed under the tree's dripline and replaced with wood chip mulch. Regular annual pruning and monitoring should be completed to help thin and reduce branch endweight. While the above recommendations are designed to stand alone to help reduce overall tree risk, it is encouraged that they be completed together to provide the best possible outcome for the tree.

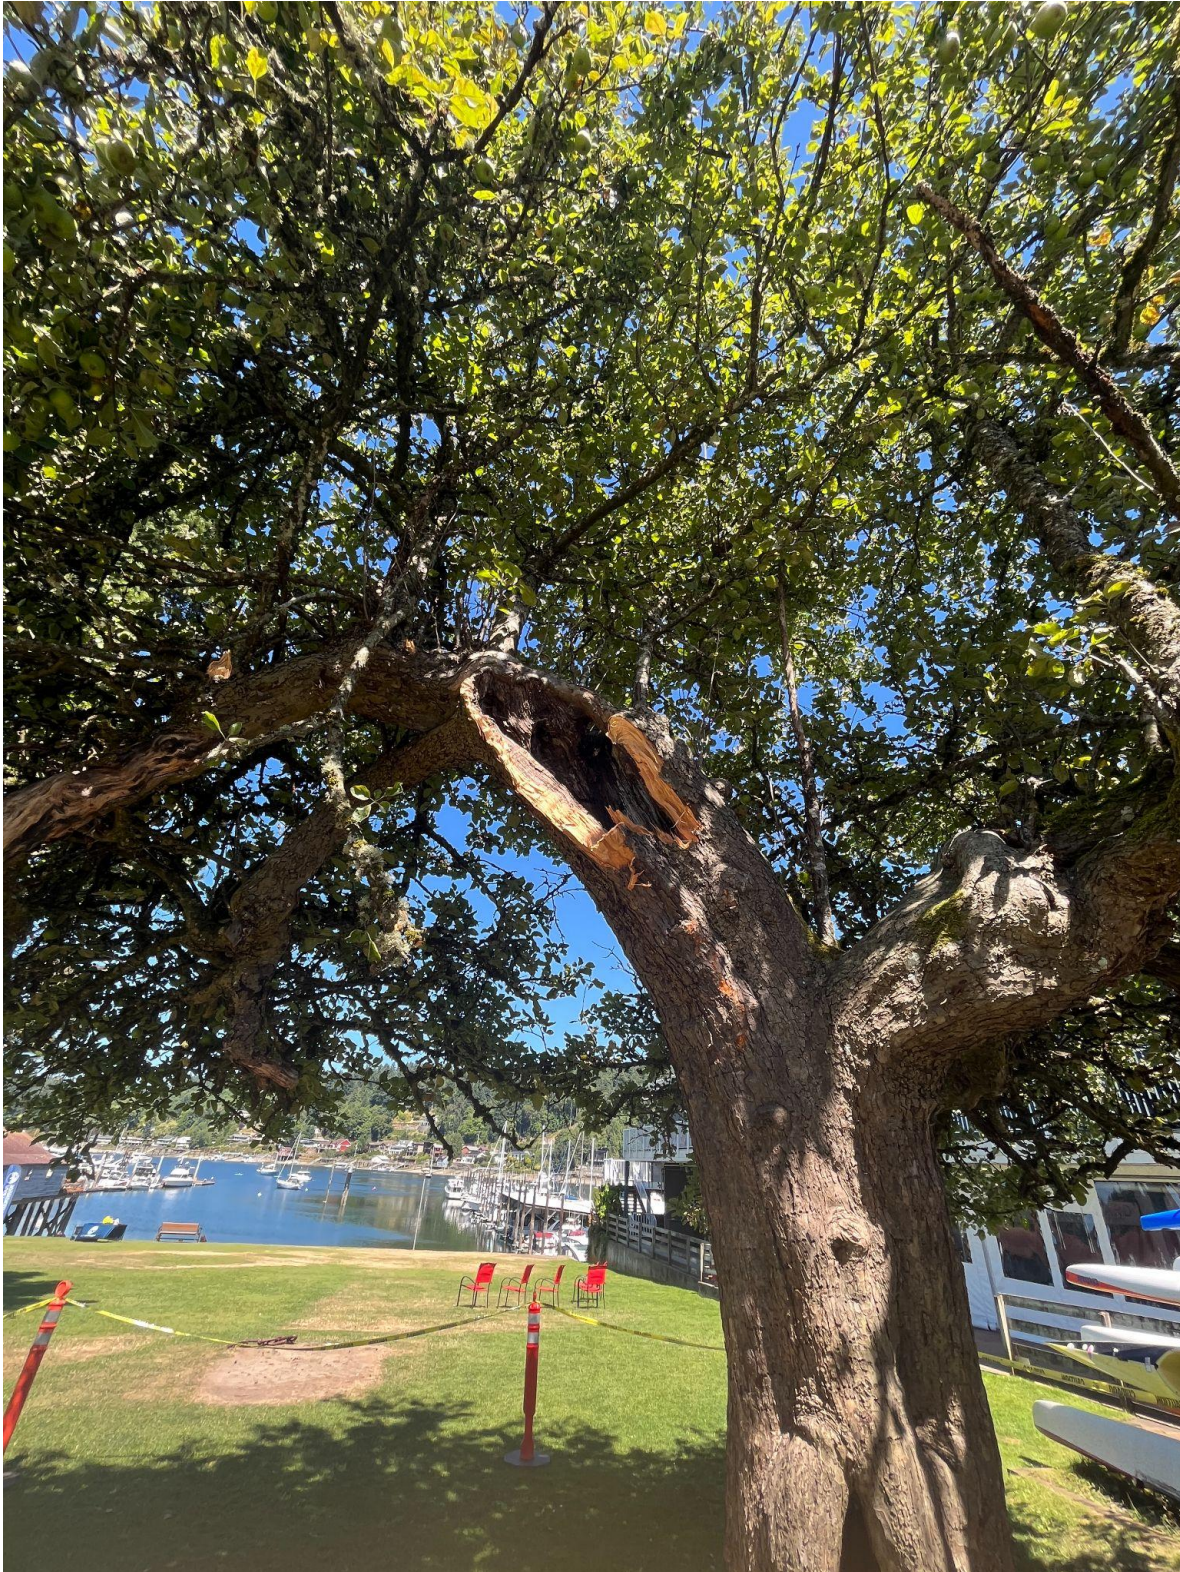
Branch failure was likely a result of extensive internal decay and a very heavy fruit crop. The likelihood of future branch failure is **probable**. Additionally, safety in the park is paramount due to the location and high traffic under the tree. The following recommendations are made to help reduce the risk associated with the tree through preservation. Risk thresholds are determined by the owner but it is important to understand that there is always some amount of risk associated with trees with valuable targets in close proximity.

***Image B2. The recent large limb failure revealed extensive internal decay that goes from the base of the tree up through the major scaffold branches. There is only a few inches, at most, of holding wood.***

### 1. Install support cables and/or branch crutches

Installation of support cabling and branch crutches should be installed after pruning to thin the canopy. Pruning goals should be focused on reducing fruit production and reducing weight on the branch unions. This would reduce the likelihood of failure from **probable to possible**, effectively reducing tree risk to **MODERATE**.

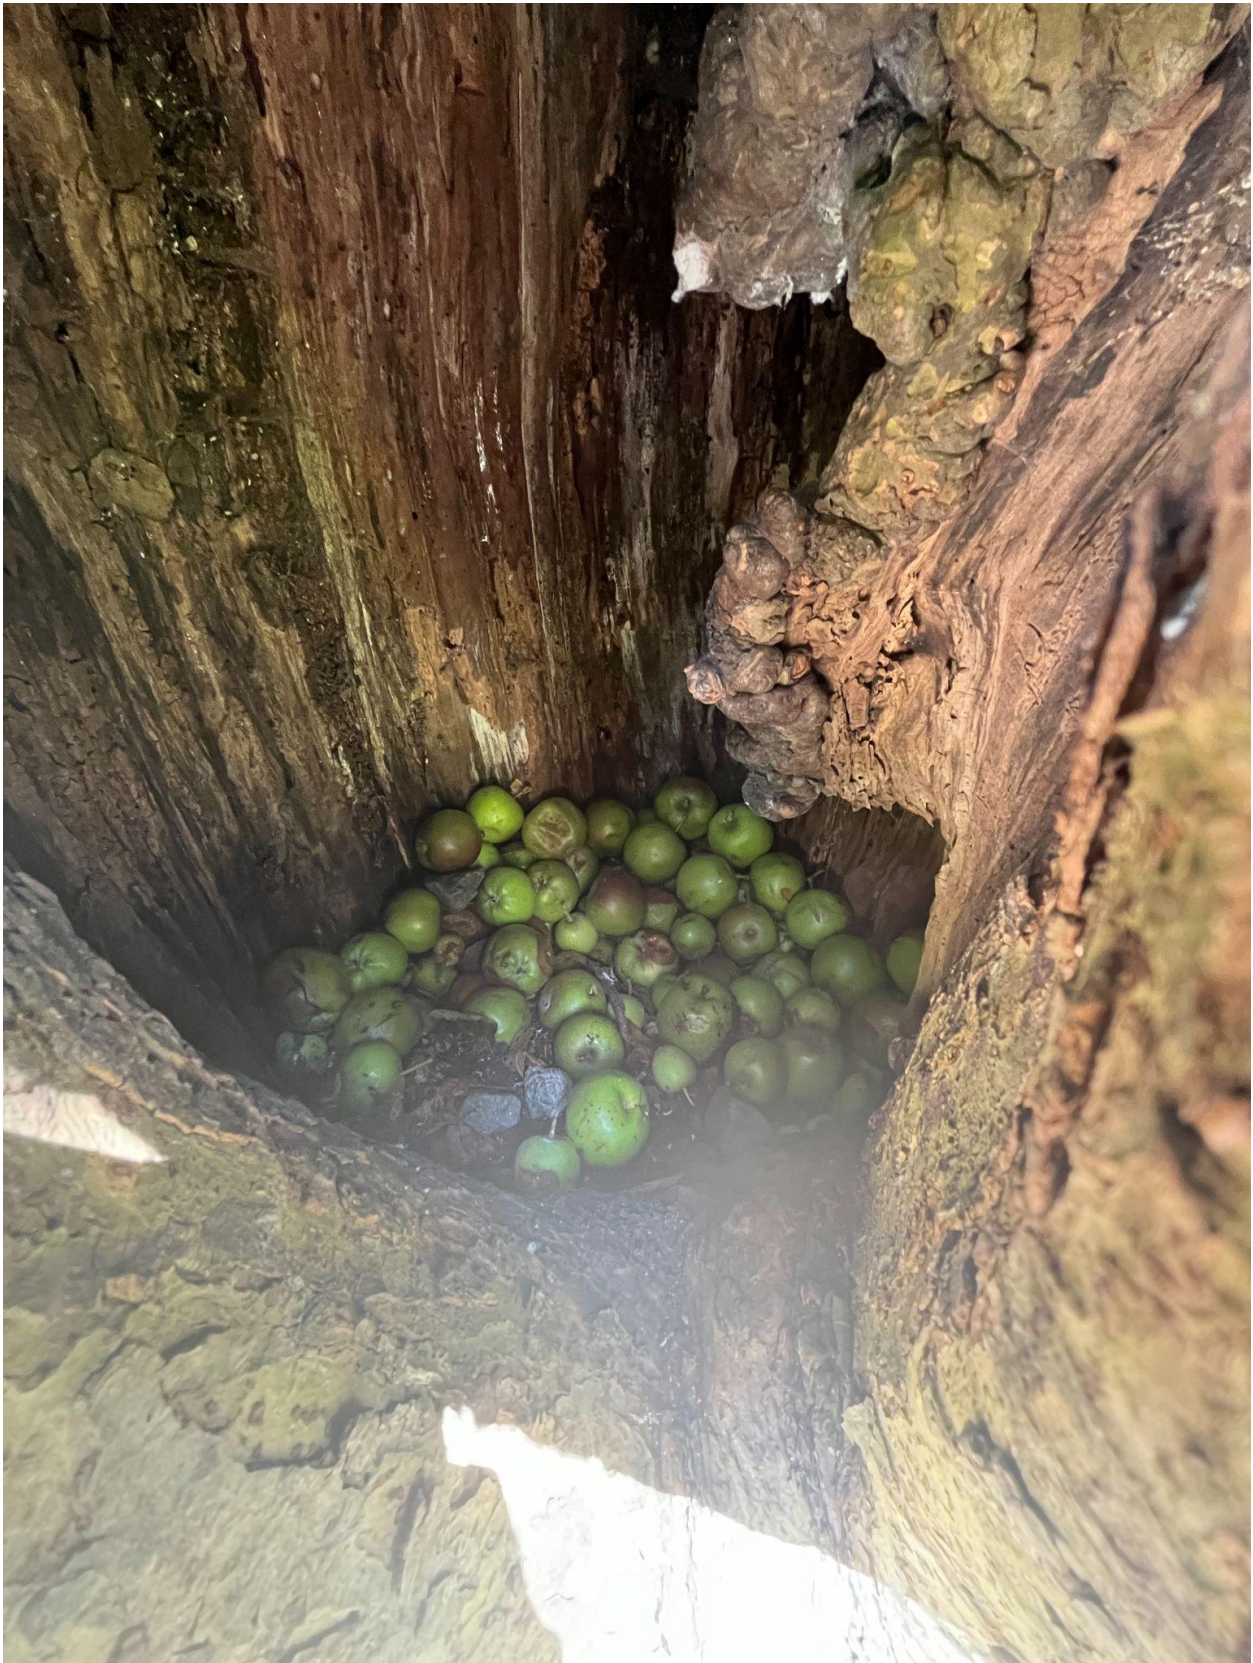
***Image B3. The base of the tree is hollow where fruit has collected.***
