**Agenda for Gig Harbor Historic Preservation Commission
Gig Harbor Civic Center
Tuesday, November 10, 2025 at 5:30 P.M.**

This meeting may also be viewed live in the Community Rooms at the Civic Center.

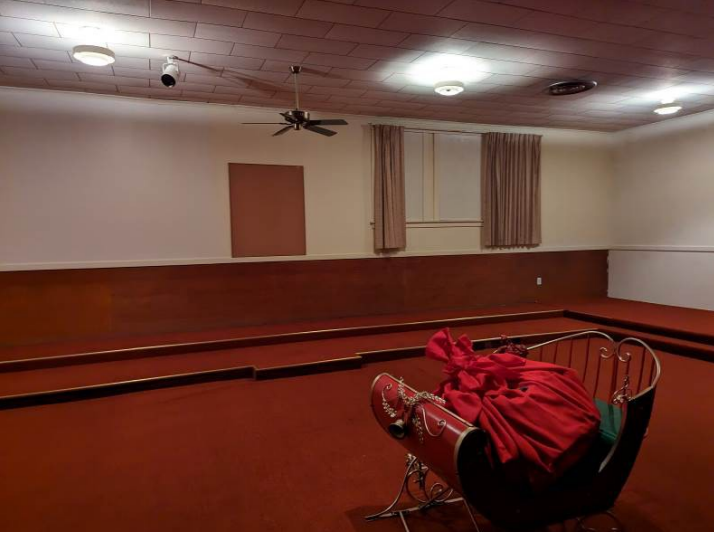
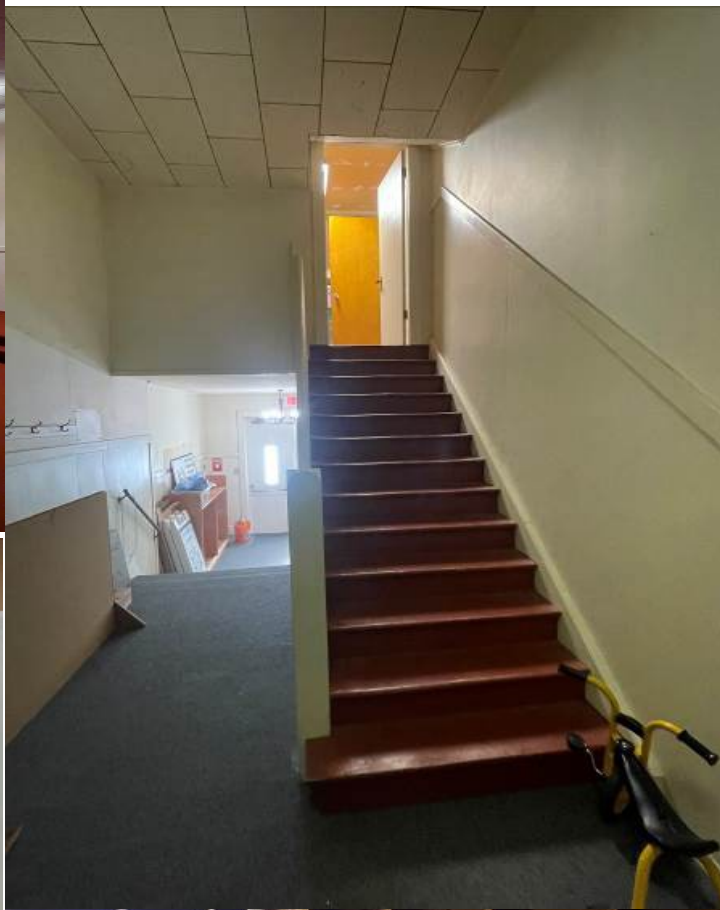
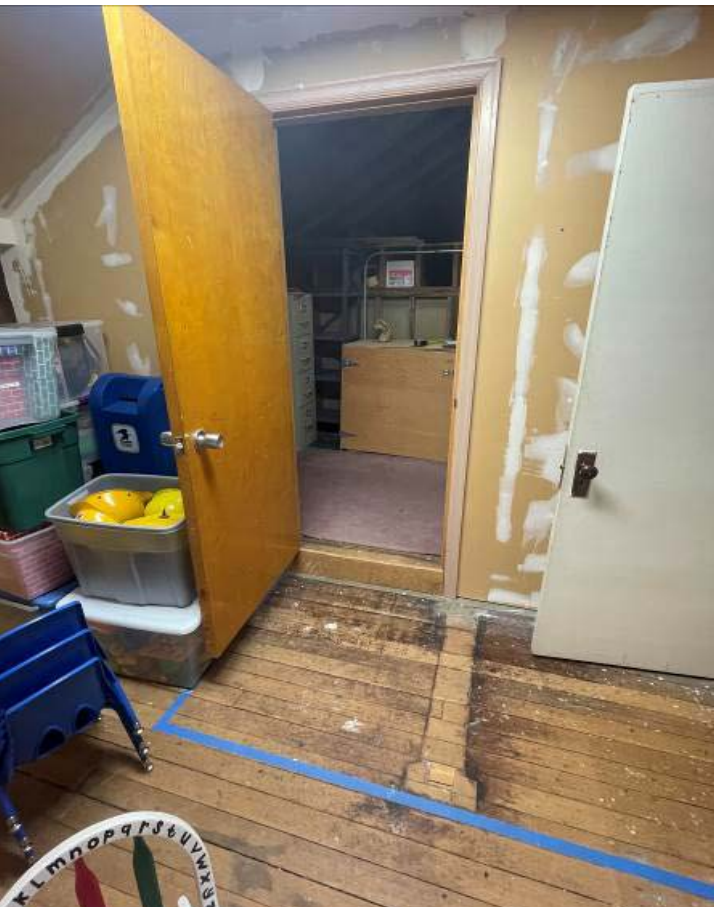
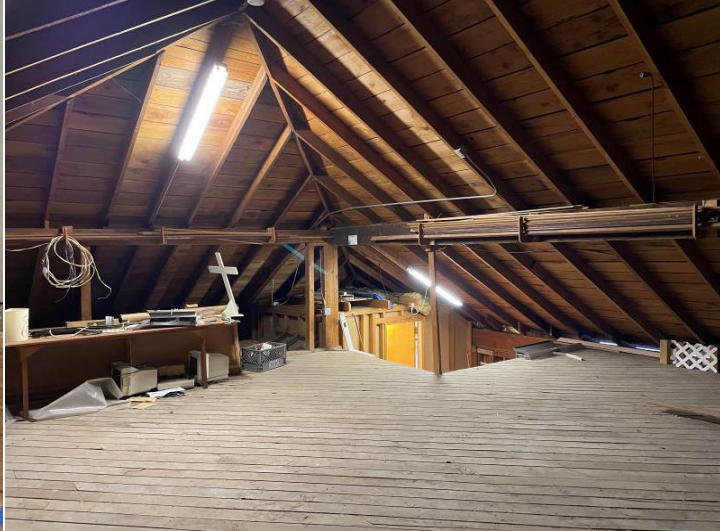
- Further revised the architecture
- Covered windows on the main floors
- Updated with vinyl siding/pillars and metal roof.
- Carpeted interior.
- Purchased by the City in 2017.

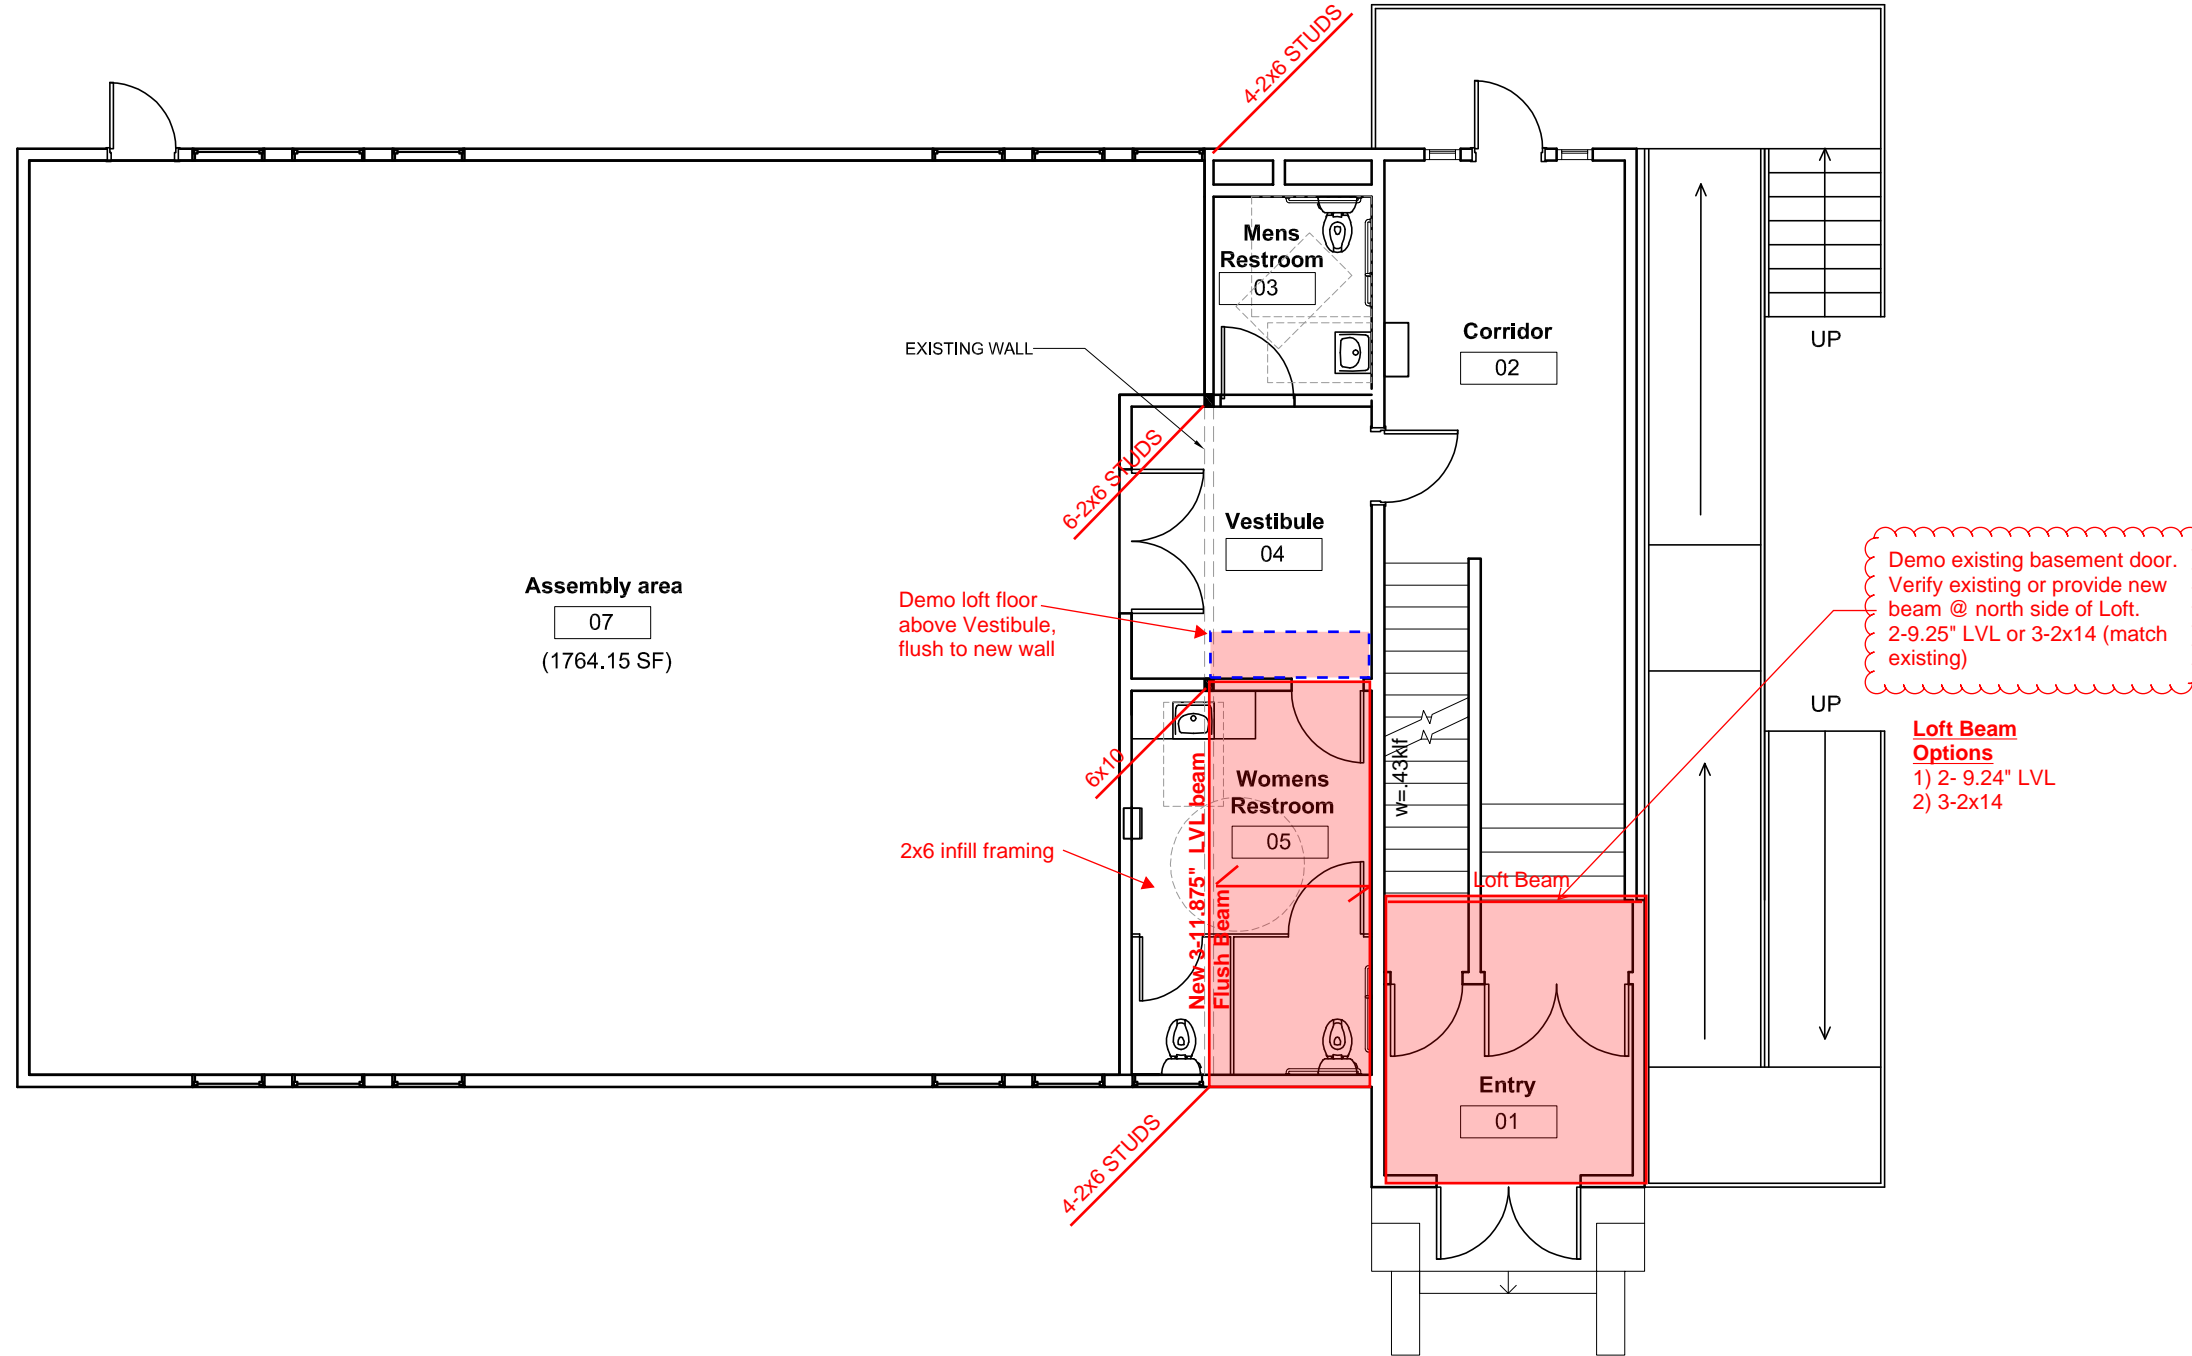
Demo existing basement door.
Verify existing or provide new
beam @ north side of Loft.
2-9.25\" LVL or 3-2x14 (match
existing)

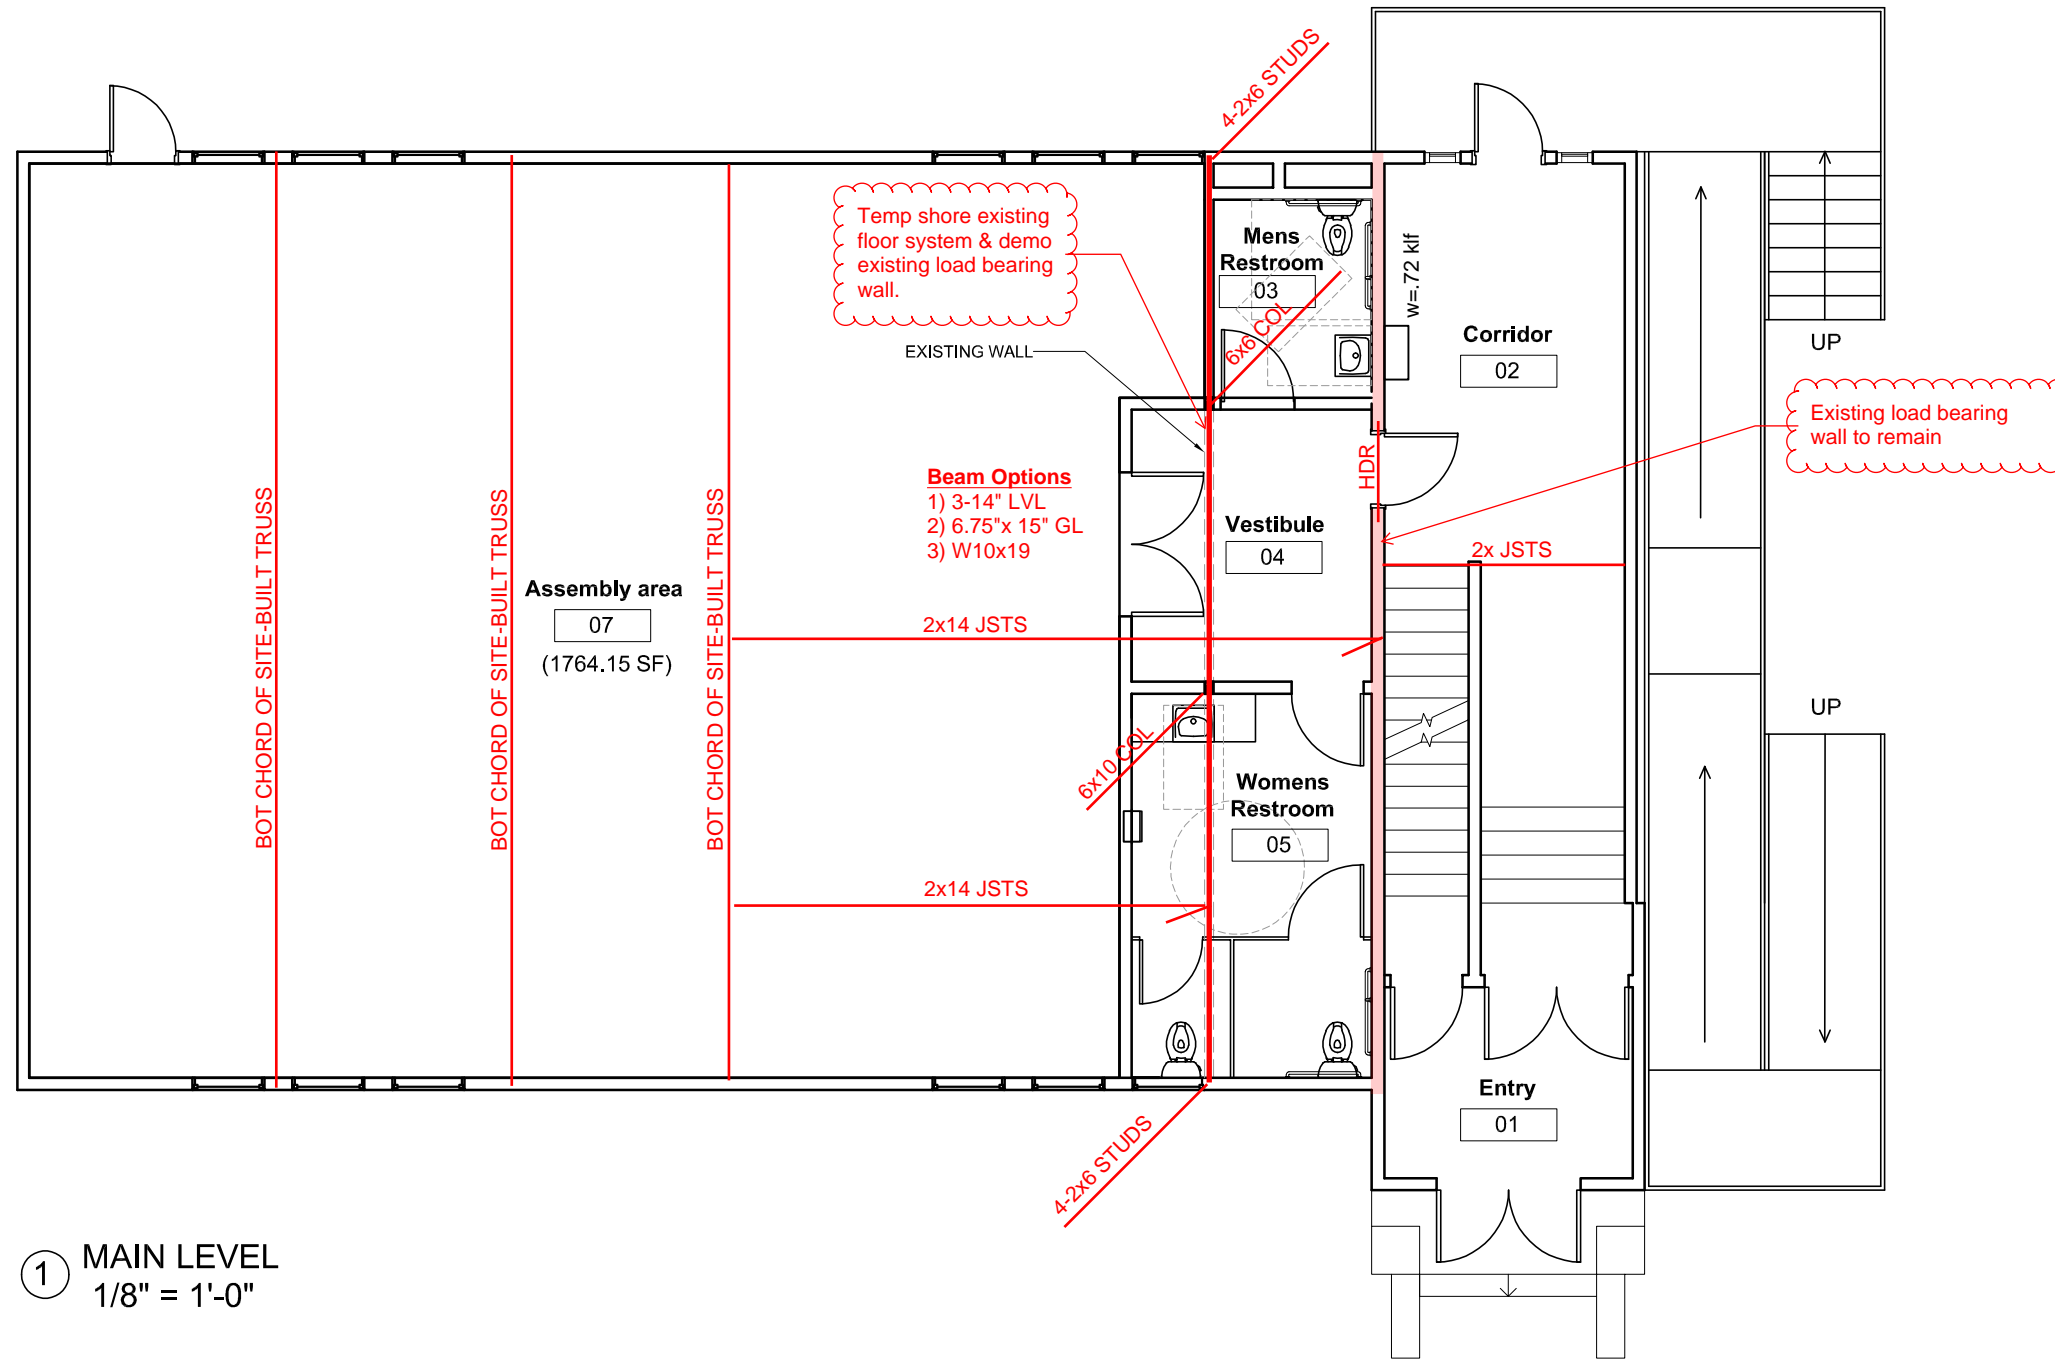
① MAIN LEVEL
1/8" = 1'-0"

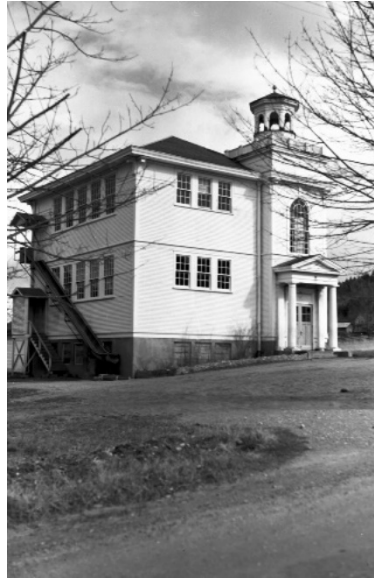
Photograph 2-1. Crecent Valley School Building – South and West Exterior prior to MTA remodel (Circa 1948). Photograph from Harbor History Museum website (www.harborhistorymuseum.org)

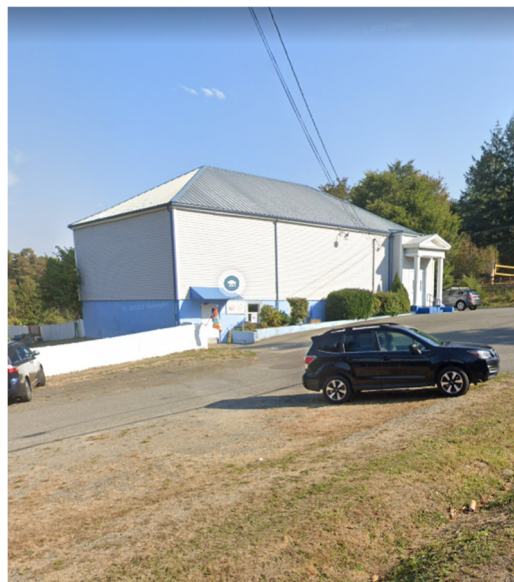
Photograph 2-2. Masonic Lodge – South and West Exterior current condition, post MTA remodel (2023). Photograph from google maps street view (maps.google.com)

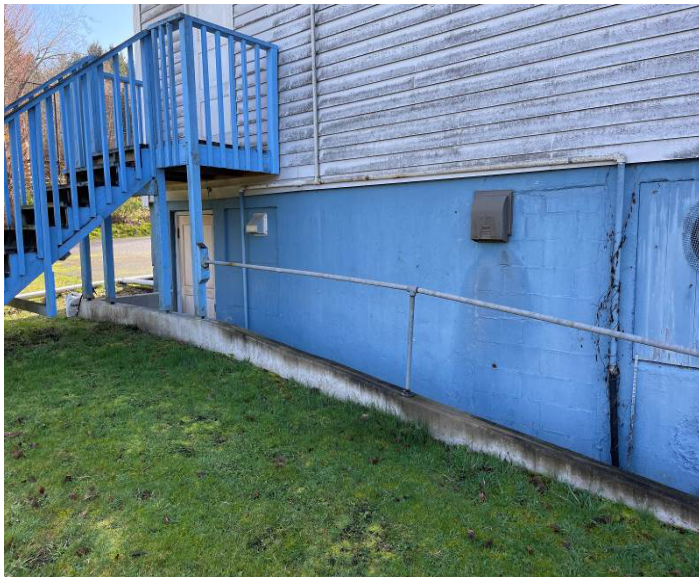
Wall with historic (left) and addition (right). Crack developed at block/concrete interface.

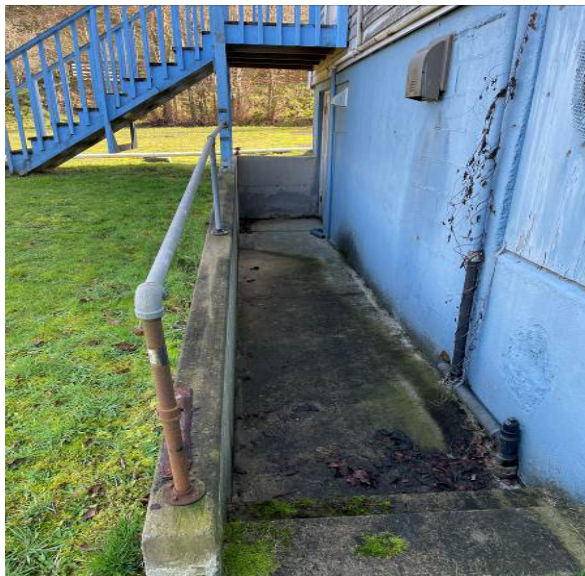
Typical condition of historic foundation. Block infill at existing opening.

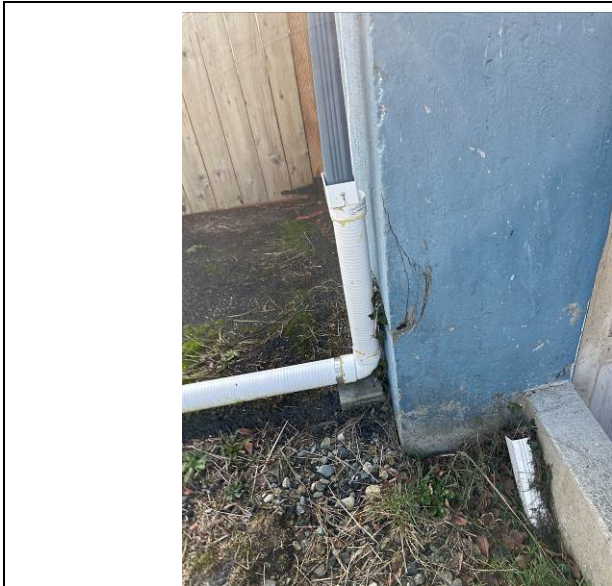
Basement access in historic foundation.

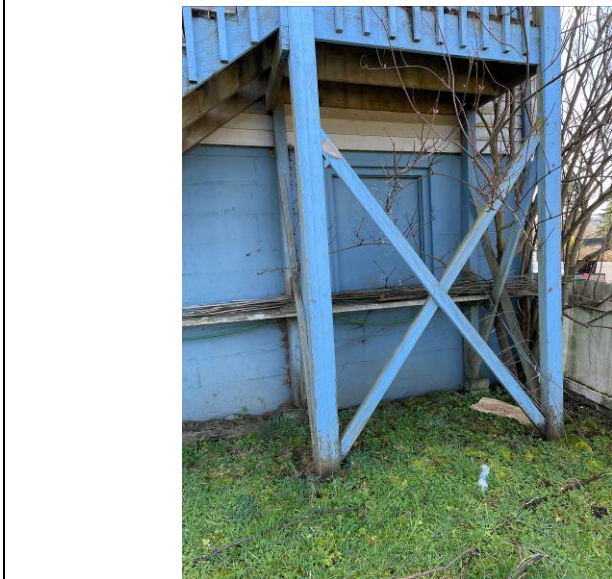
Concrete damage. Possible rebar exposure.

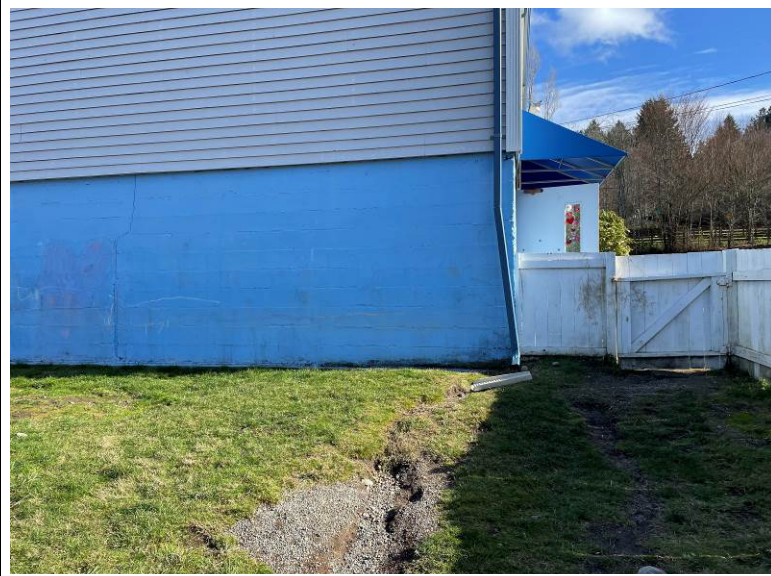
Water infiltration risk at interface of historic foundation and addition.

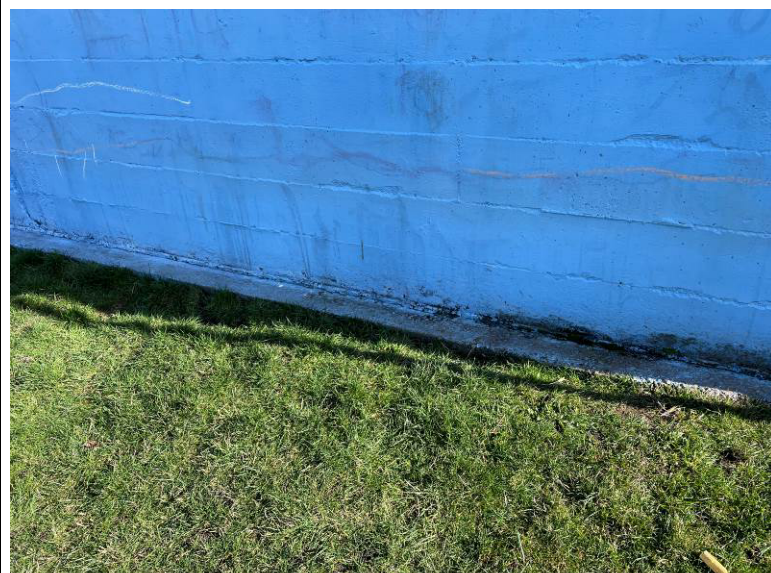
Overview of south end of west addition basement wall.
Note cracks near center

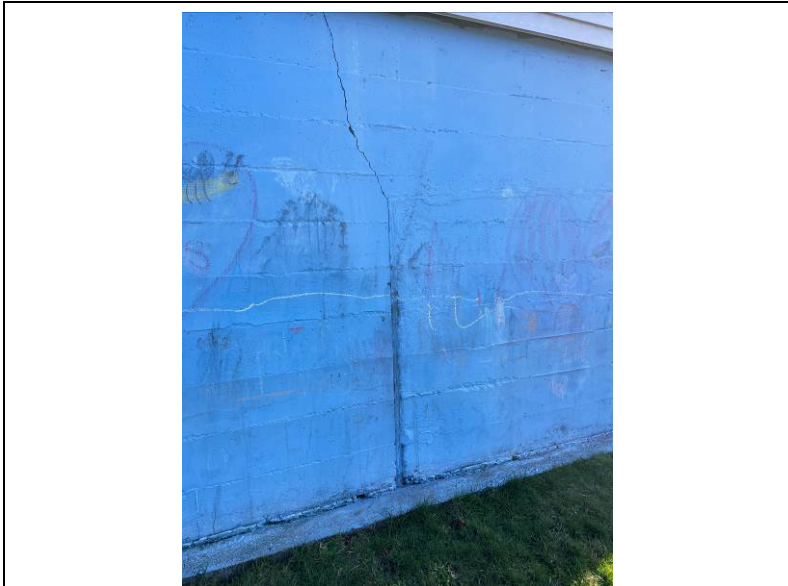
Photograph No. 10
Exterior, west wall, looking east

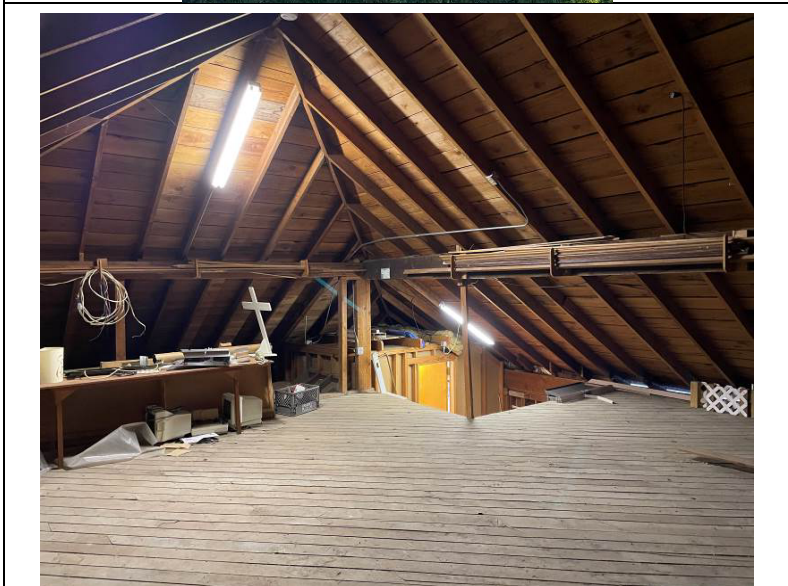
Photograph No. 11
Interior, attic, looking SE

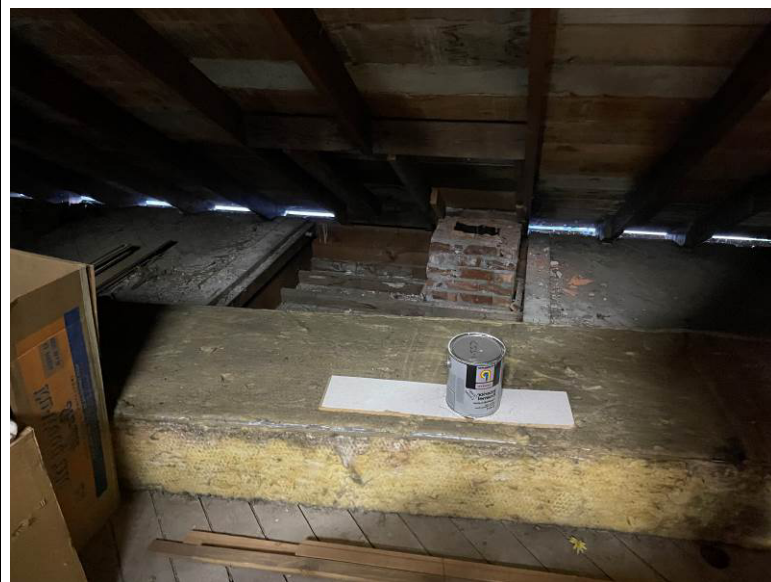
General condition of roof and 2nd floor over historic portion of structure.

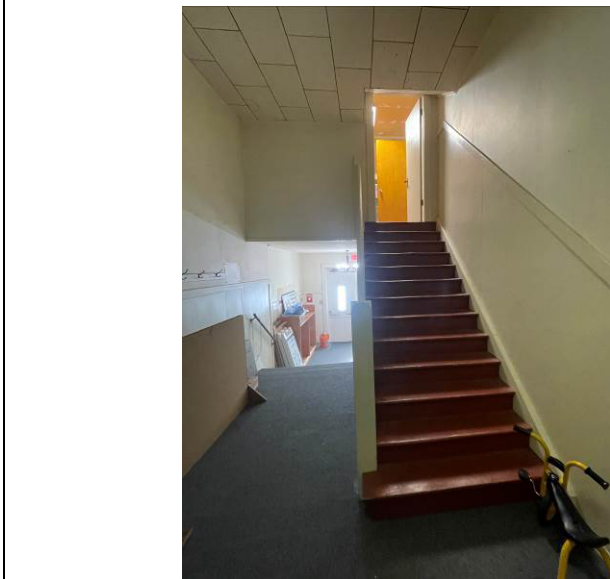
Typical interior condition

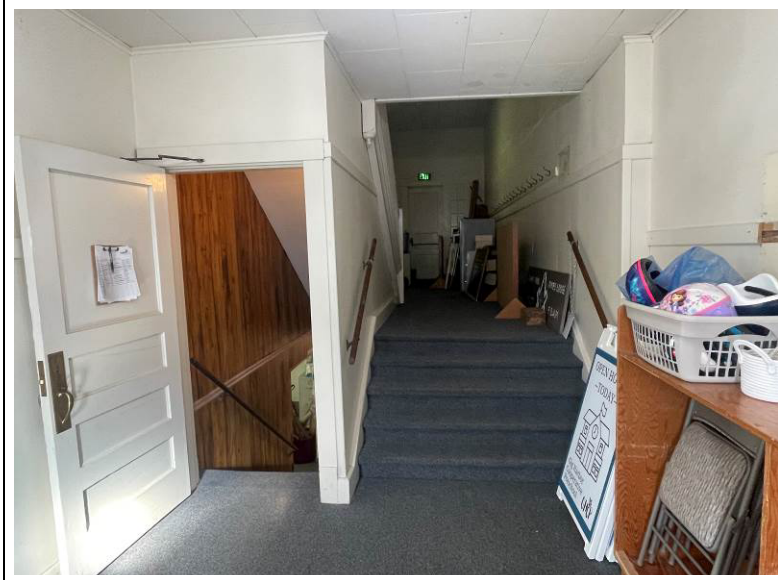
Typical interior condition

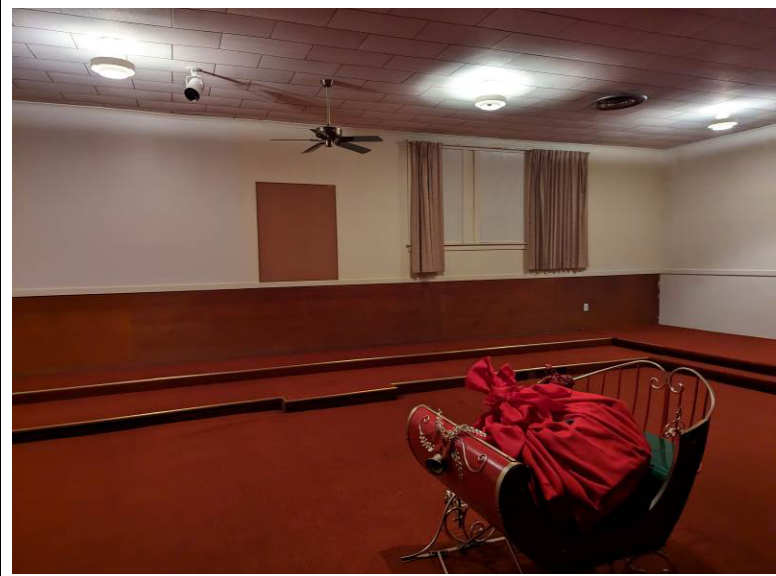
Photograph No. 18
Interior, main floor, looking south

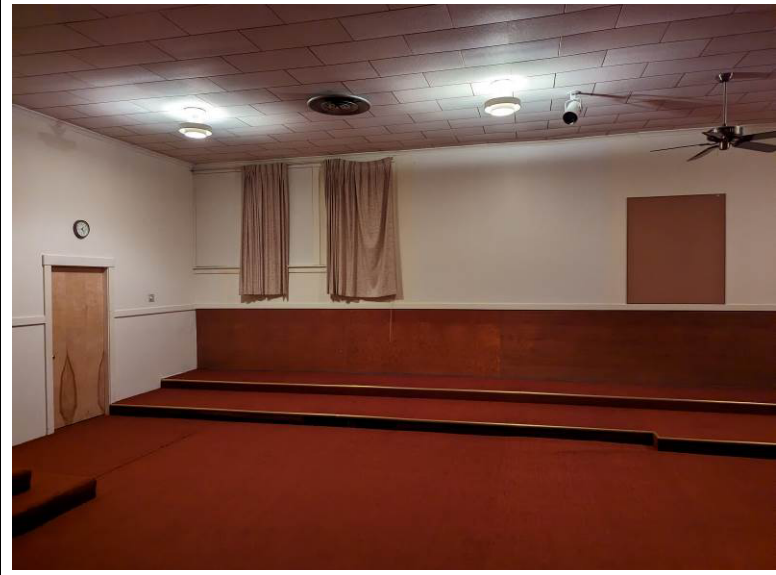
Photograph No. 18
Interior, main floor, looking south

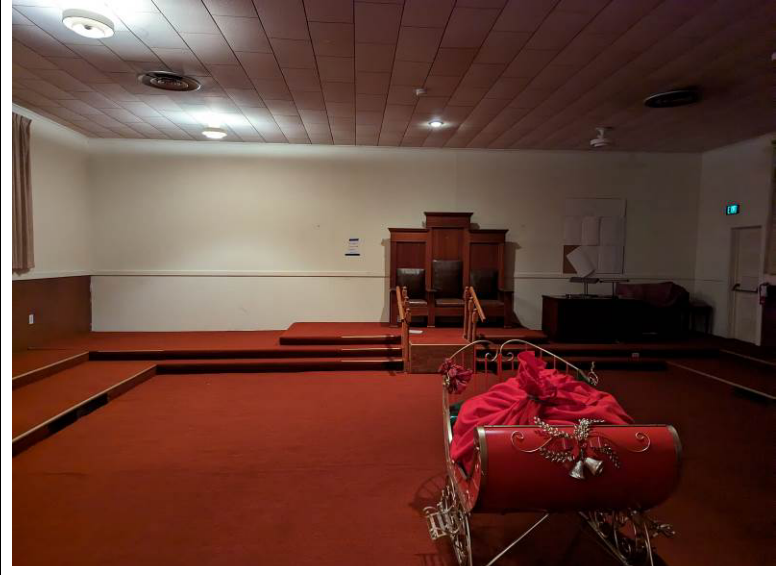
Photograph No. 18
Interior, main floor, looking west

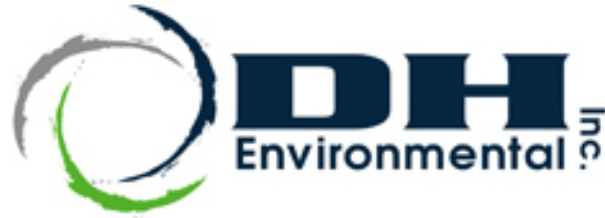
Hazardous Building Materials Assessment

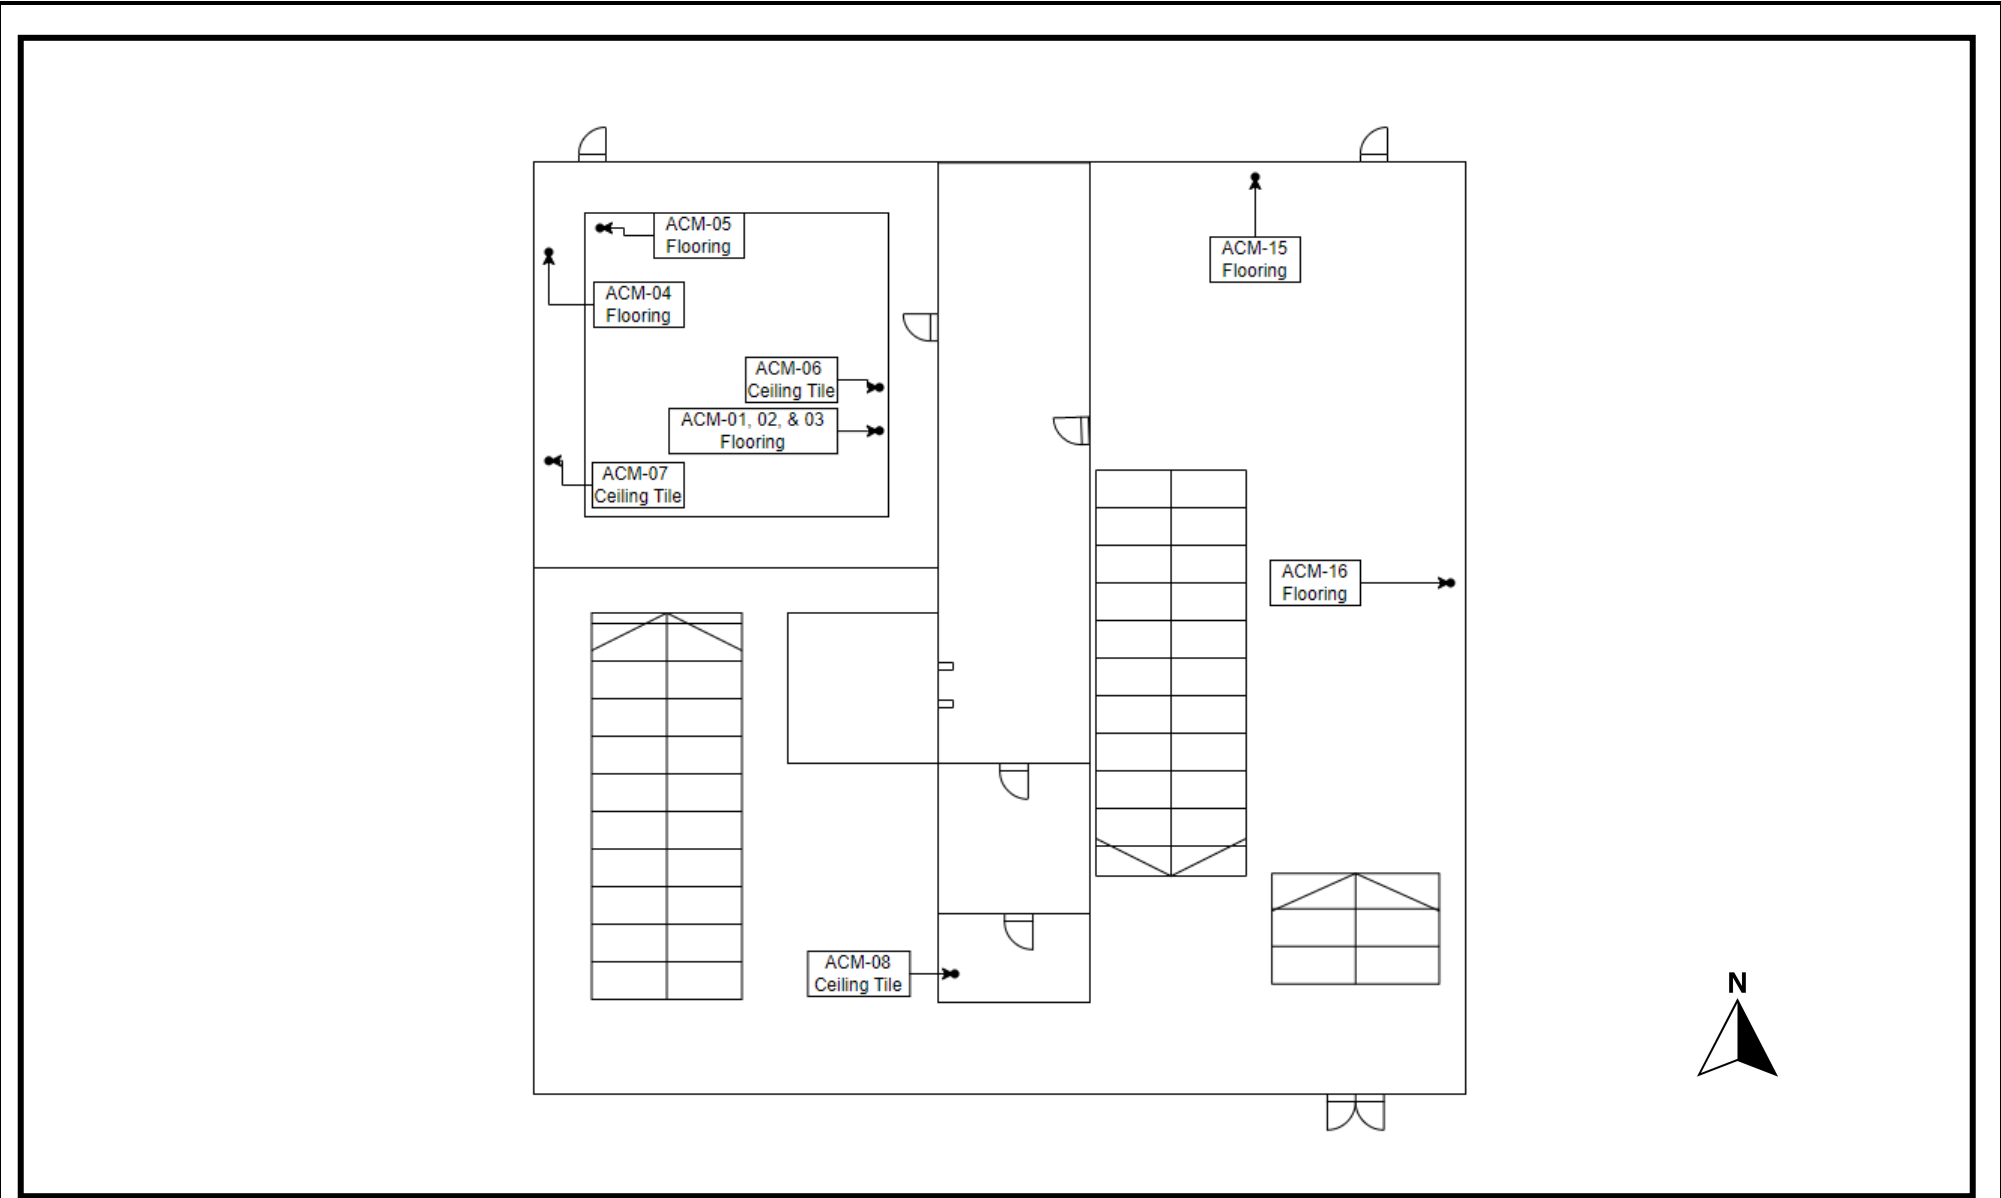
Figure 1 Sample Locations: Main Floor Asbestos Assessment

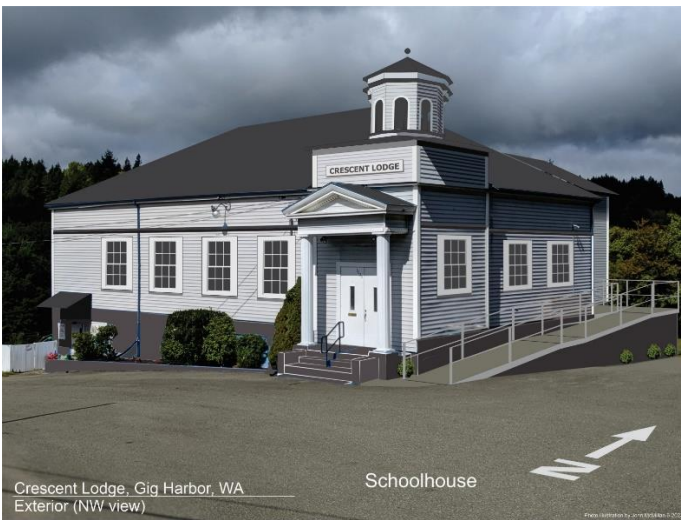
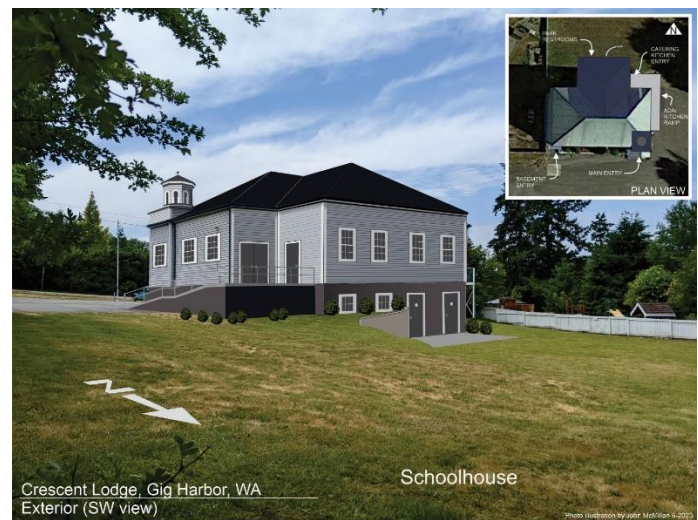
The recommended concept design addresses user needs for ADA, upper park restrooms, parking, and preservation of open space. Special thanks to John McMillian for developing the concept renderings.

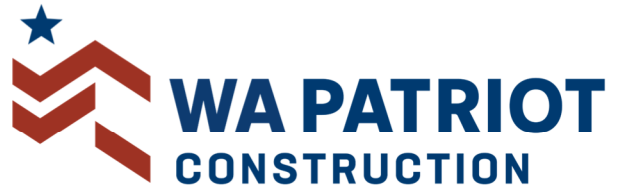
CRESCENT LODGE GIG HARBOR MASONIC TEMPLE

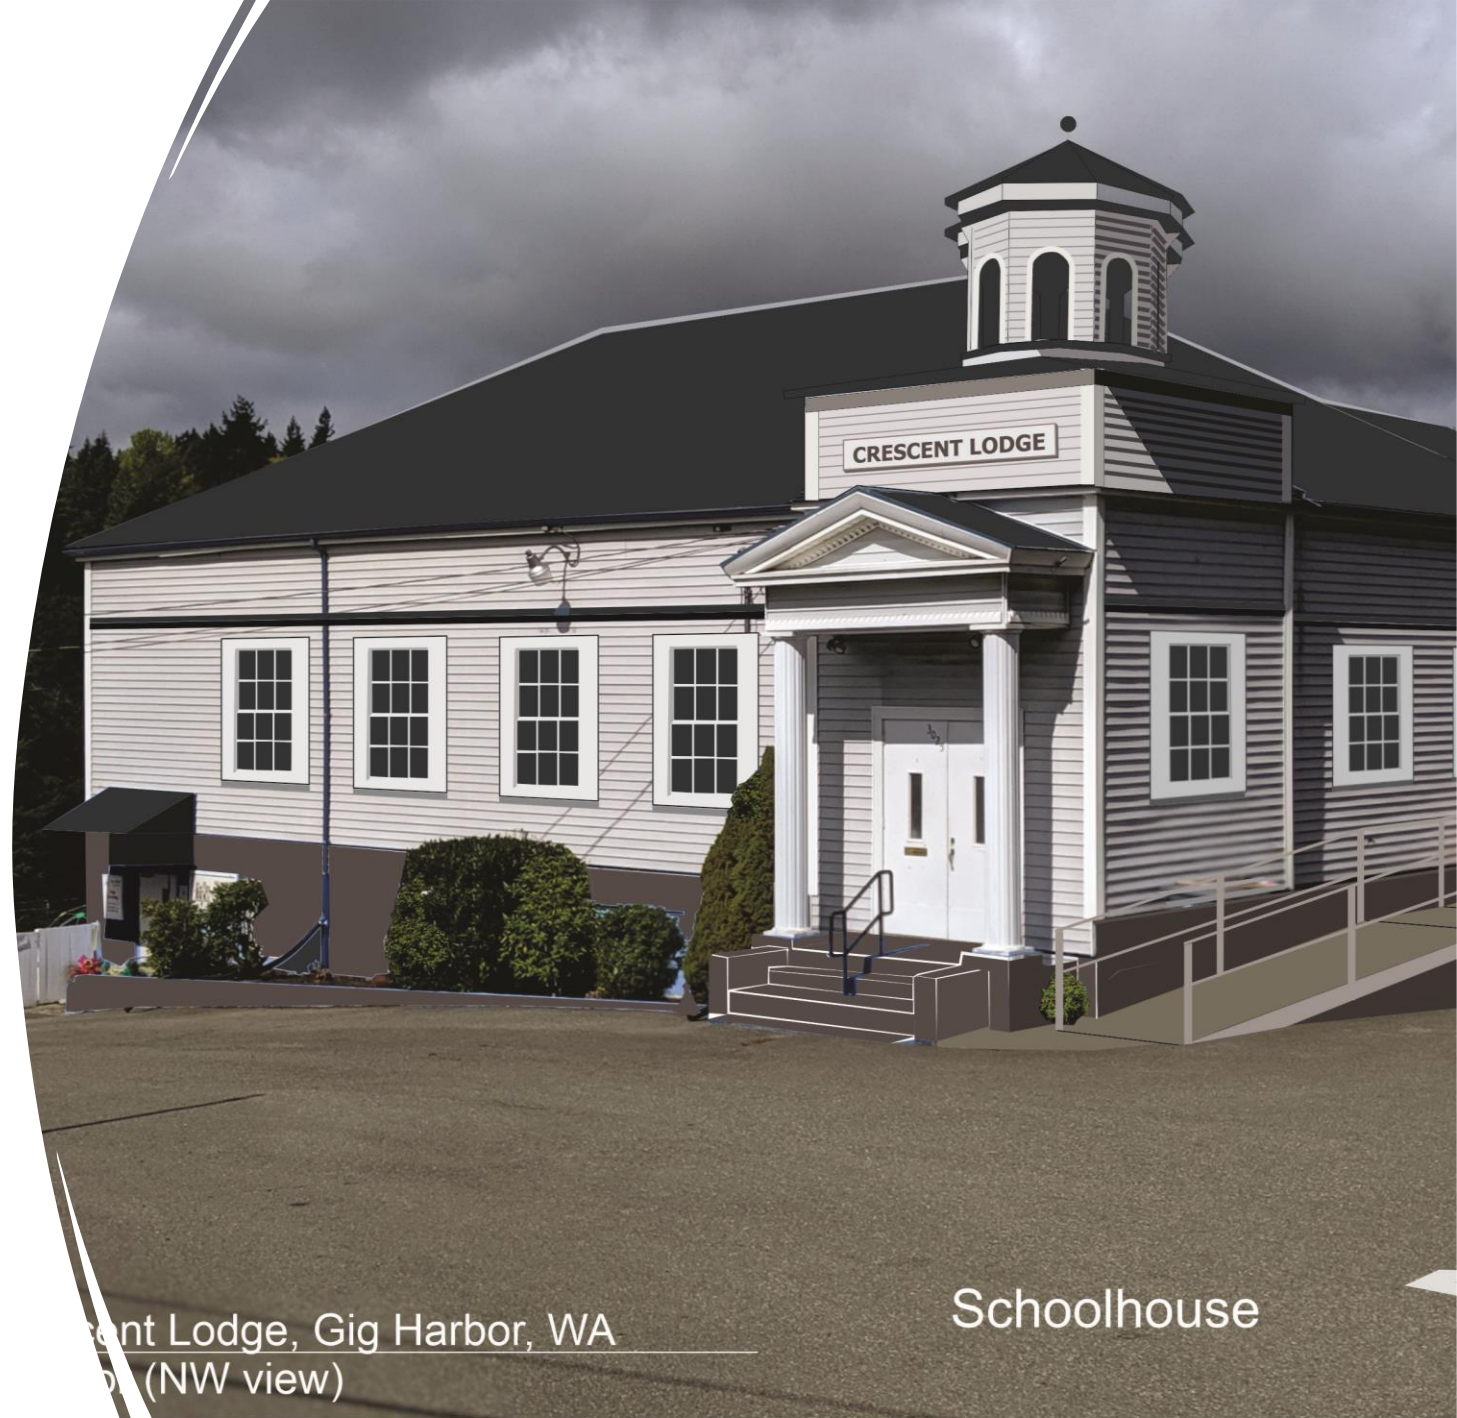
Crescent Lodge, Gig Harbor, WA
(NW view)
