AGENDA
GIG HARBOR CITY COUNCIL STUDY SESSION
Thursday, April 16, 2026 - 3:00 PM
Community Rooms

SUBJECT: Manganese Feasibility Study Discussion and Next Steps.

SUBJECT: City-owned Residential Rentals Overview

TO: Jeff Langhelm
CC: Jeff Olsen, Kyle Neiman, Peter Frontiero
FROM: Jennifer Haro, Parks Manager
DATE: 1/28/2025
SUBJECT: Wilkinson Farm House

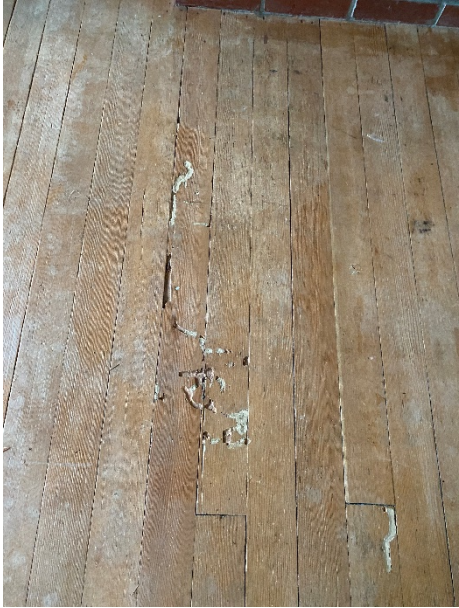
1 Termite damage in floor

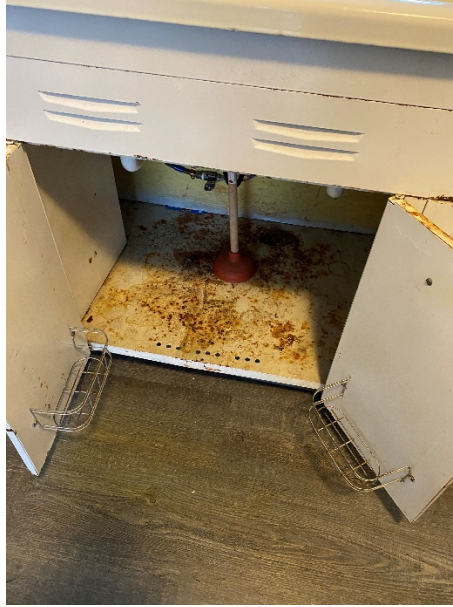
Rusty sink cabinet

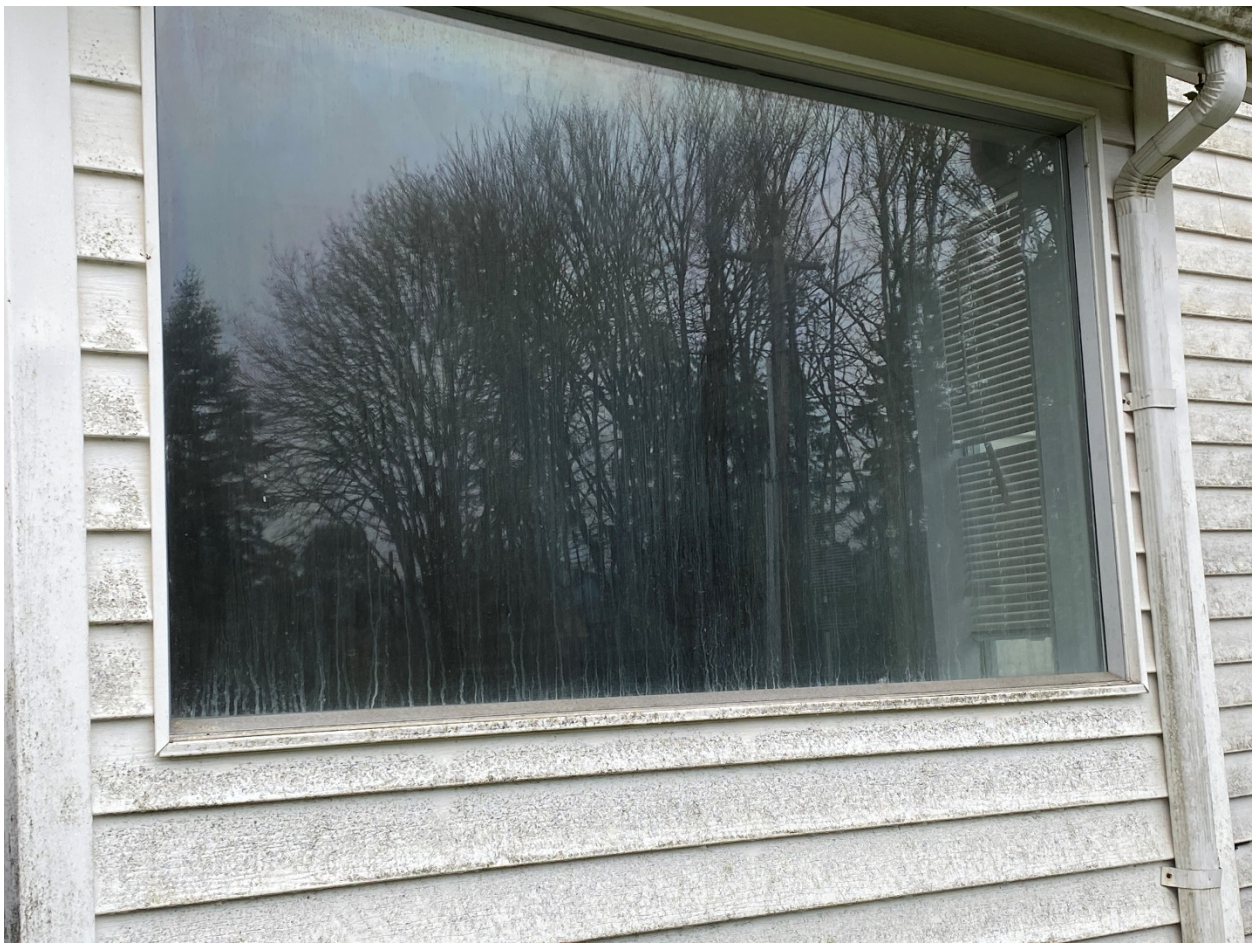
2 Mildewed siding and cloudy picture window

Based upon professional judgement, the best course of action for now is to leave the house vacant, with basic maintenance, until a long-term plan for the park is developed.
